# Debris/Ice/TPS Assessment And Photographic Analysis For Shuttle Mission STS-44

Gregory N. Katnik  
NASA/Kennedy Space Center

November 24, 1991

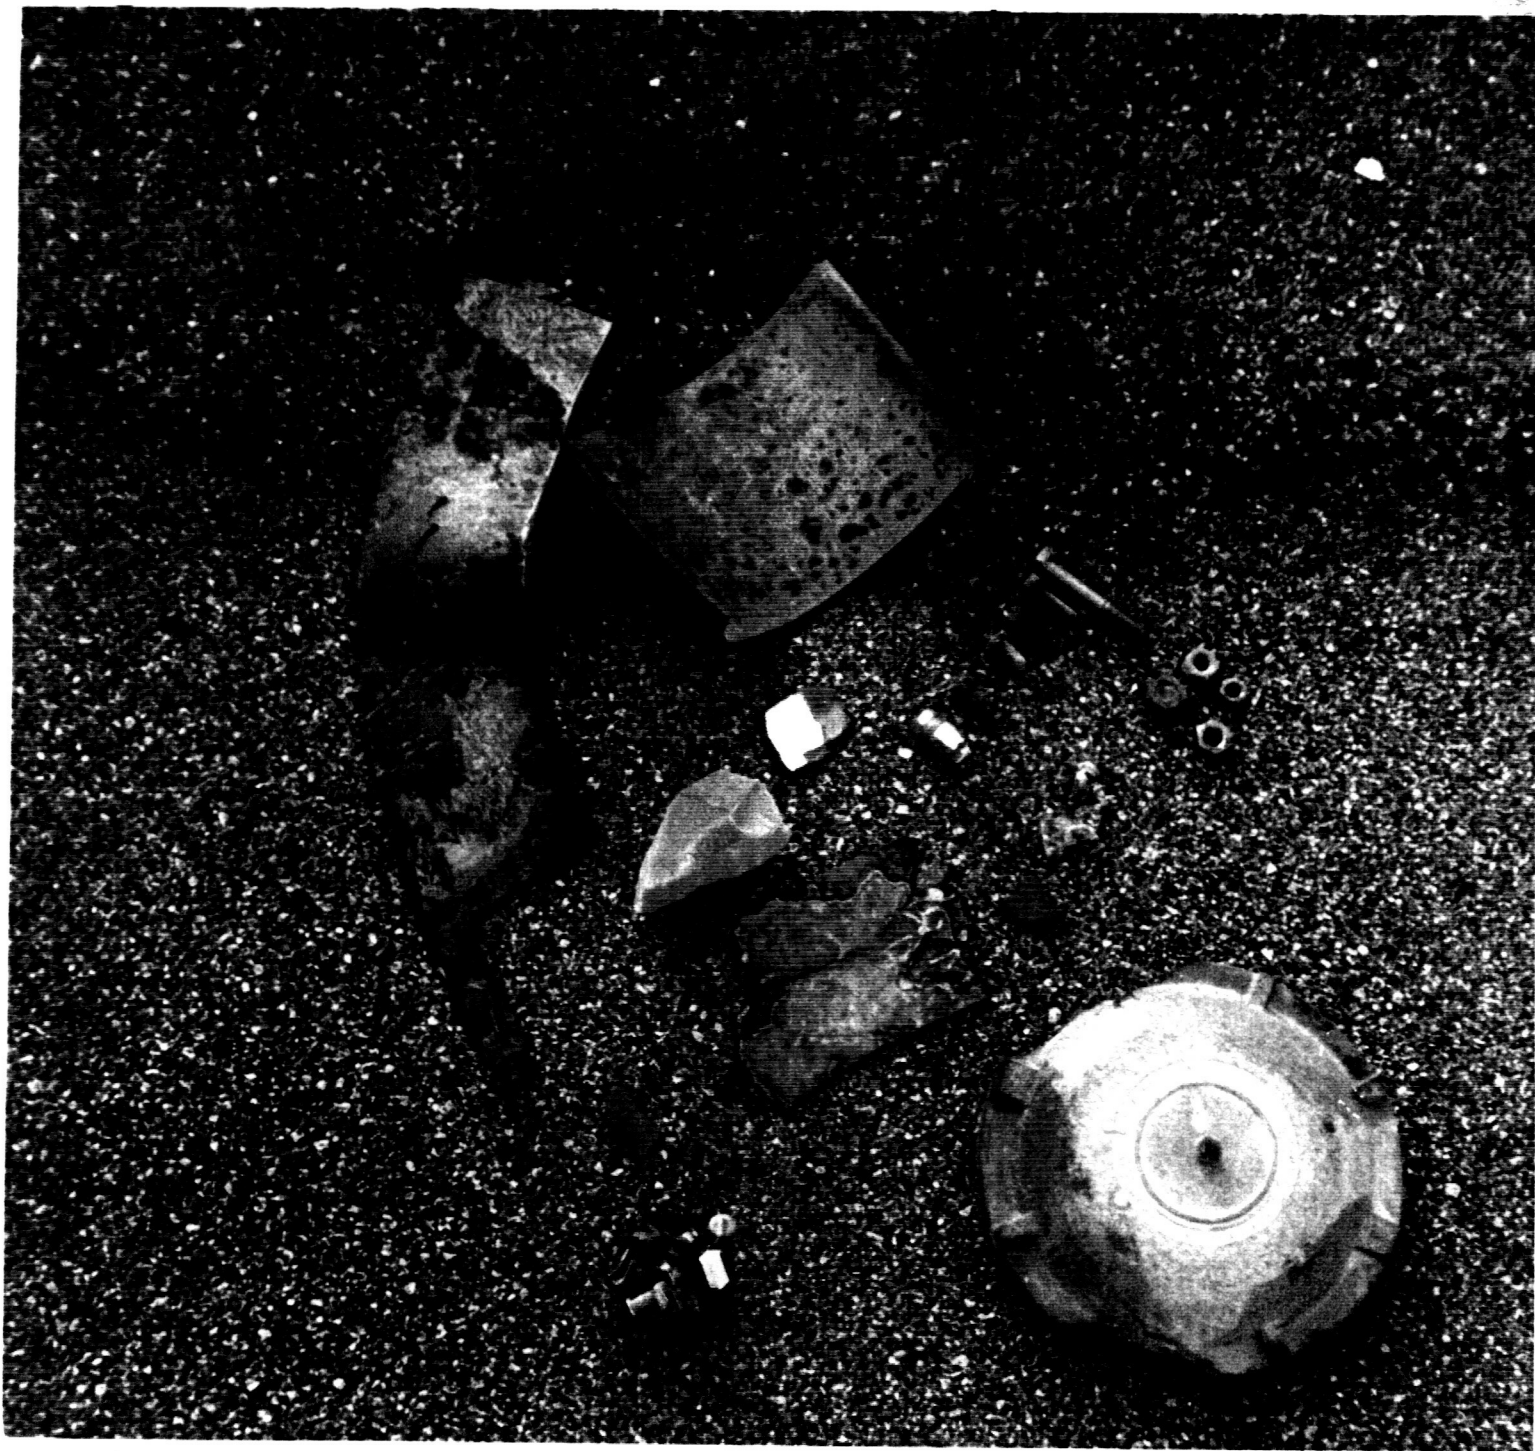
Typical post launch debris included SRB throat plug material  
and facility nuts, bolts, line caps, and covers

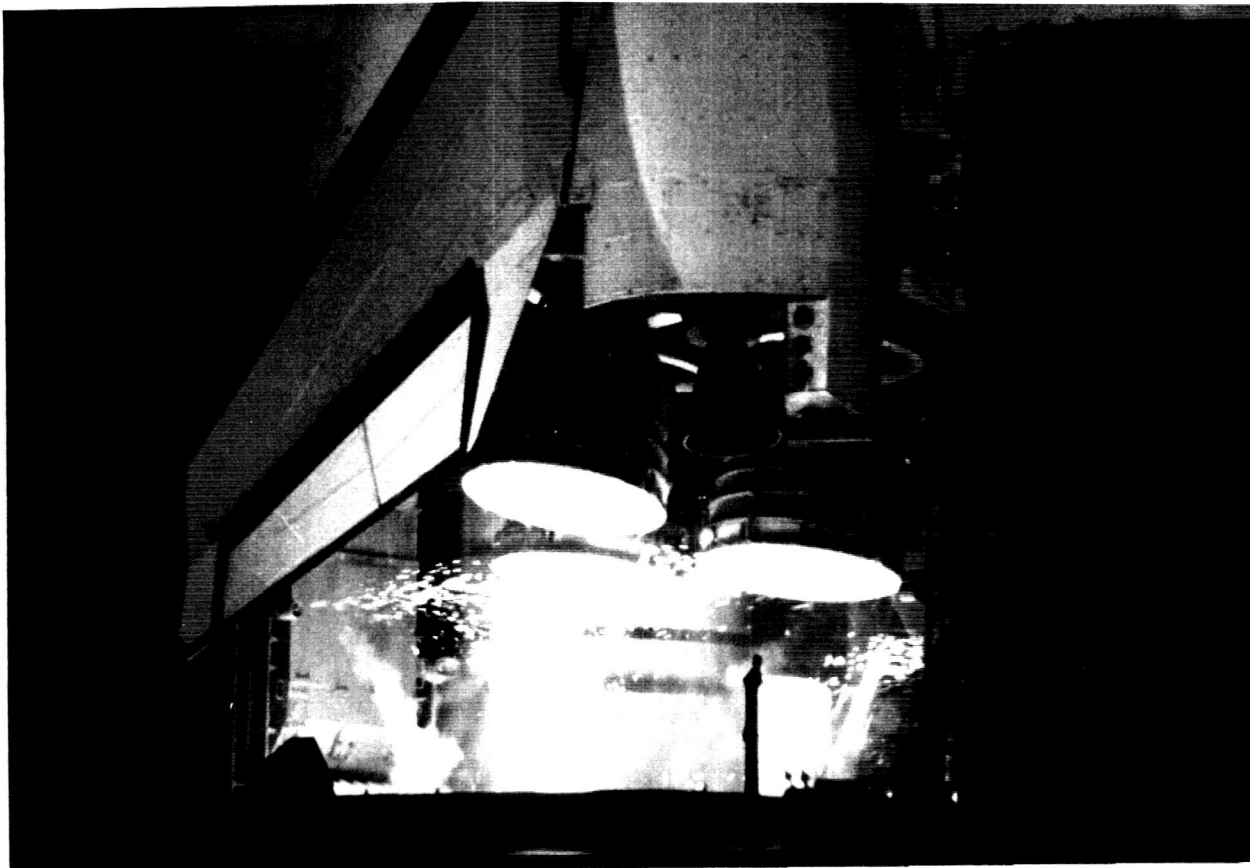
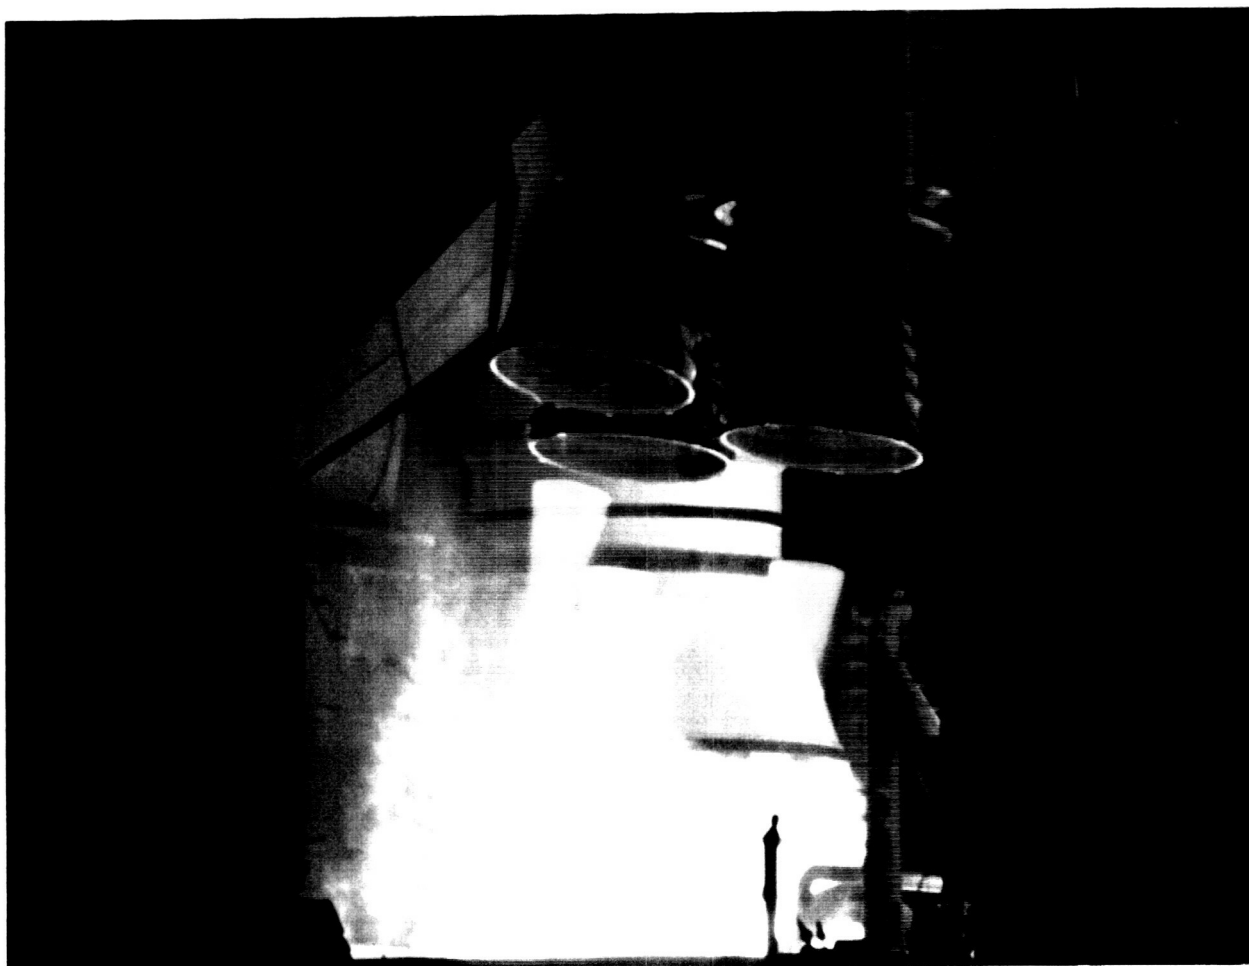
View from Camera E-76 shows orange streaks along edges of SSME plumes during ignition. The streaks had disappeared by liftoff.

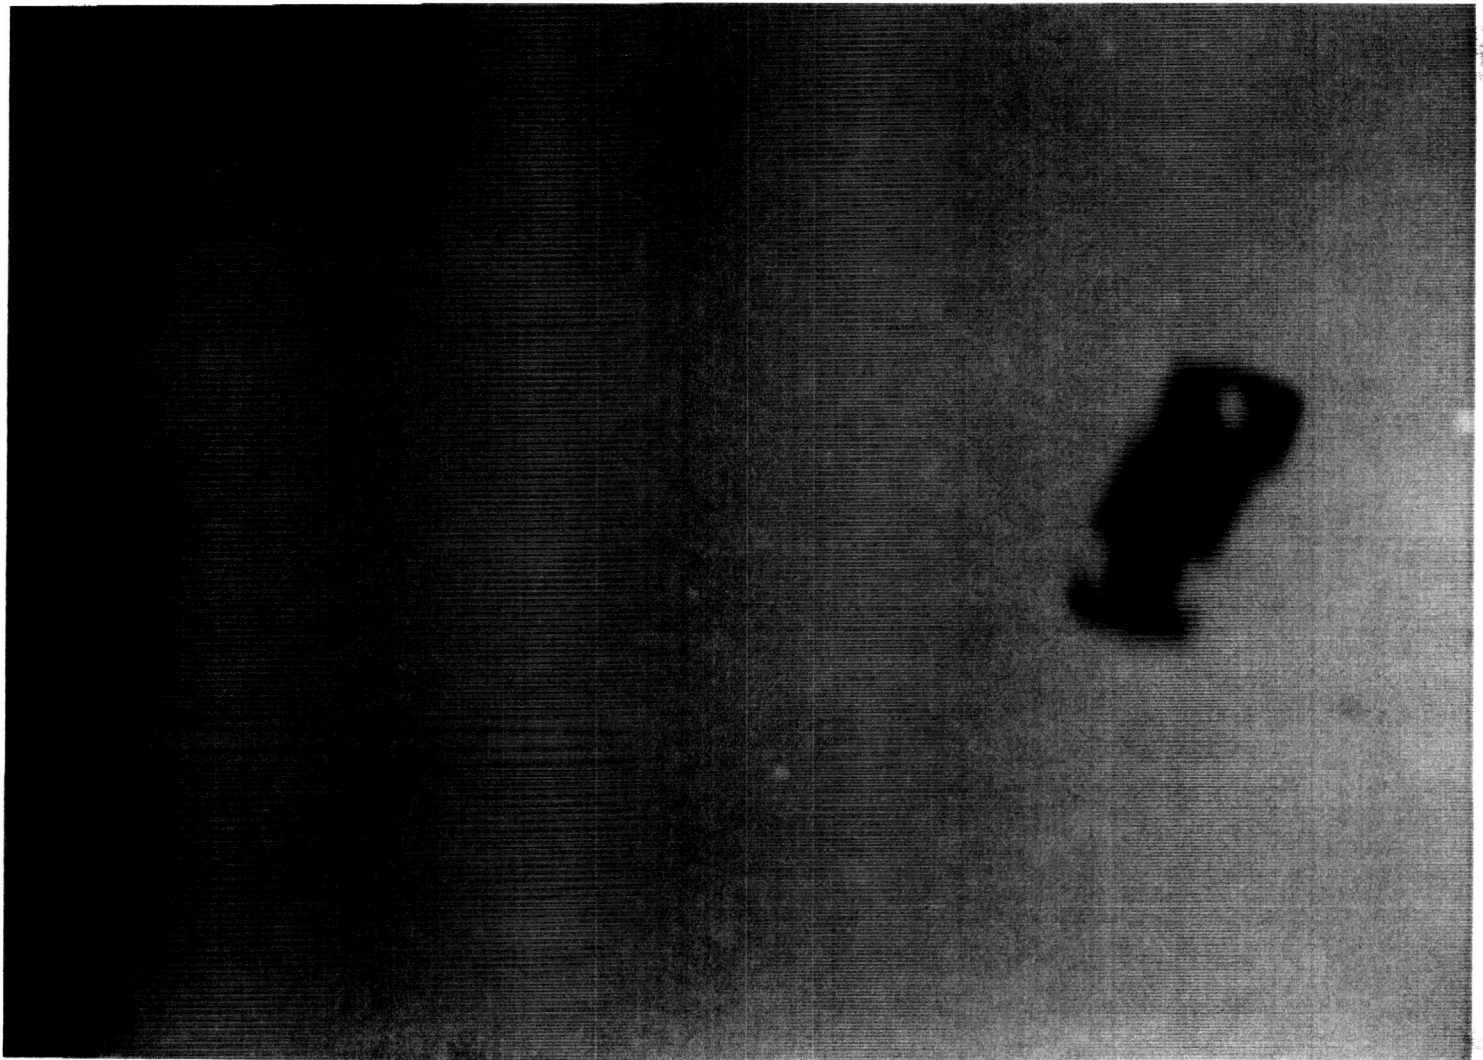
A facility line bracket, approximately four inches in length, passed close to the Camera E-40 lens well after the vehicle had cleared the tower.

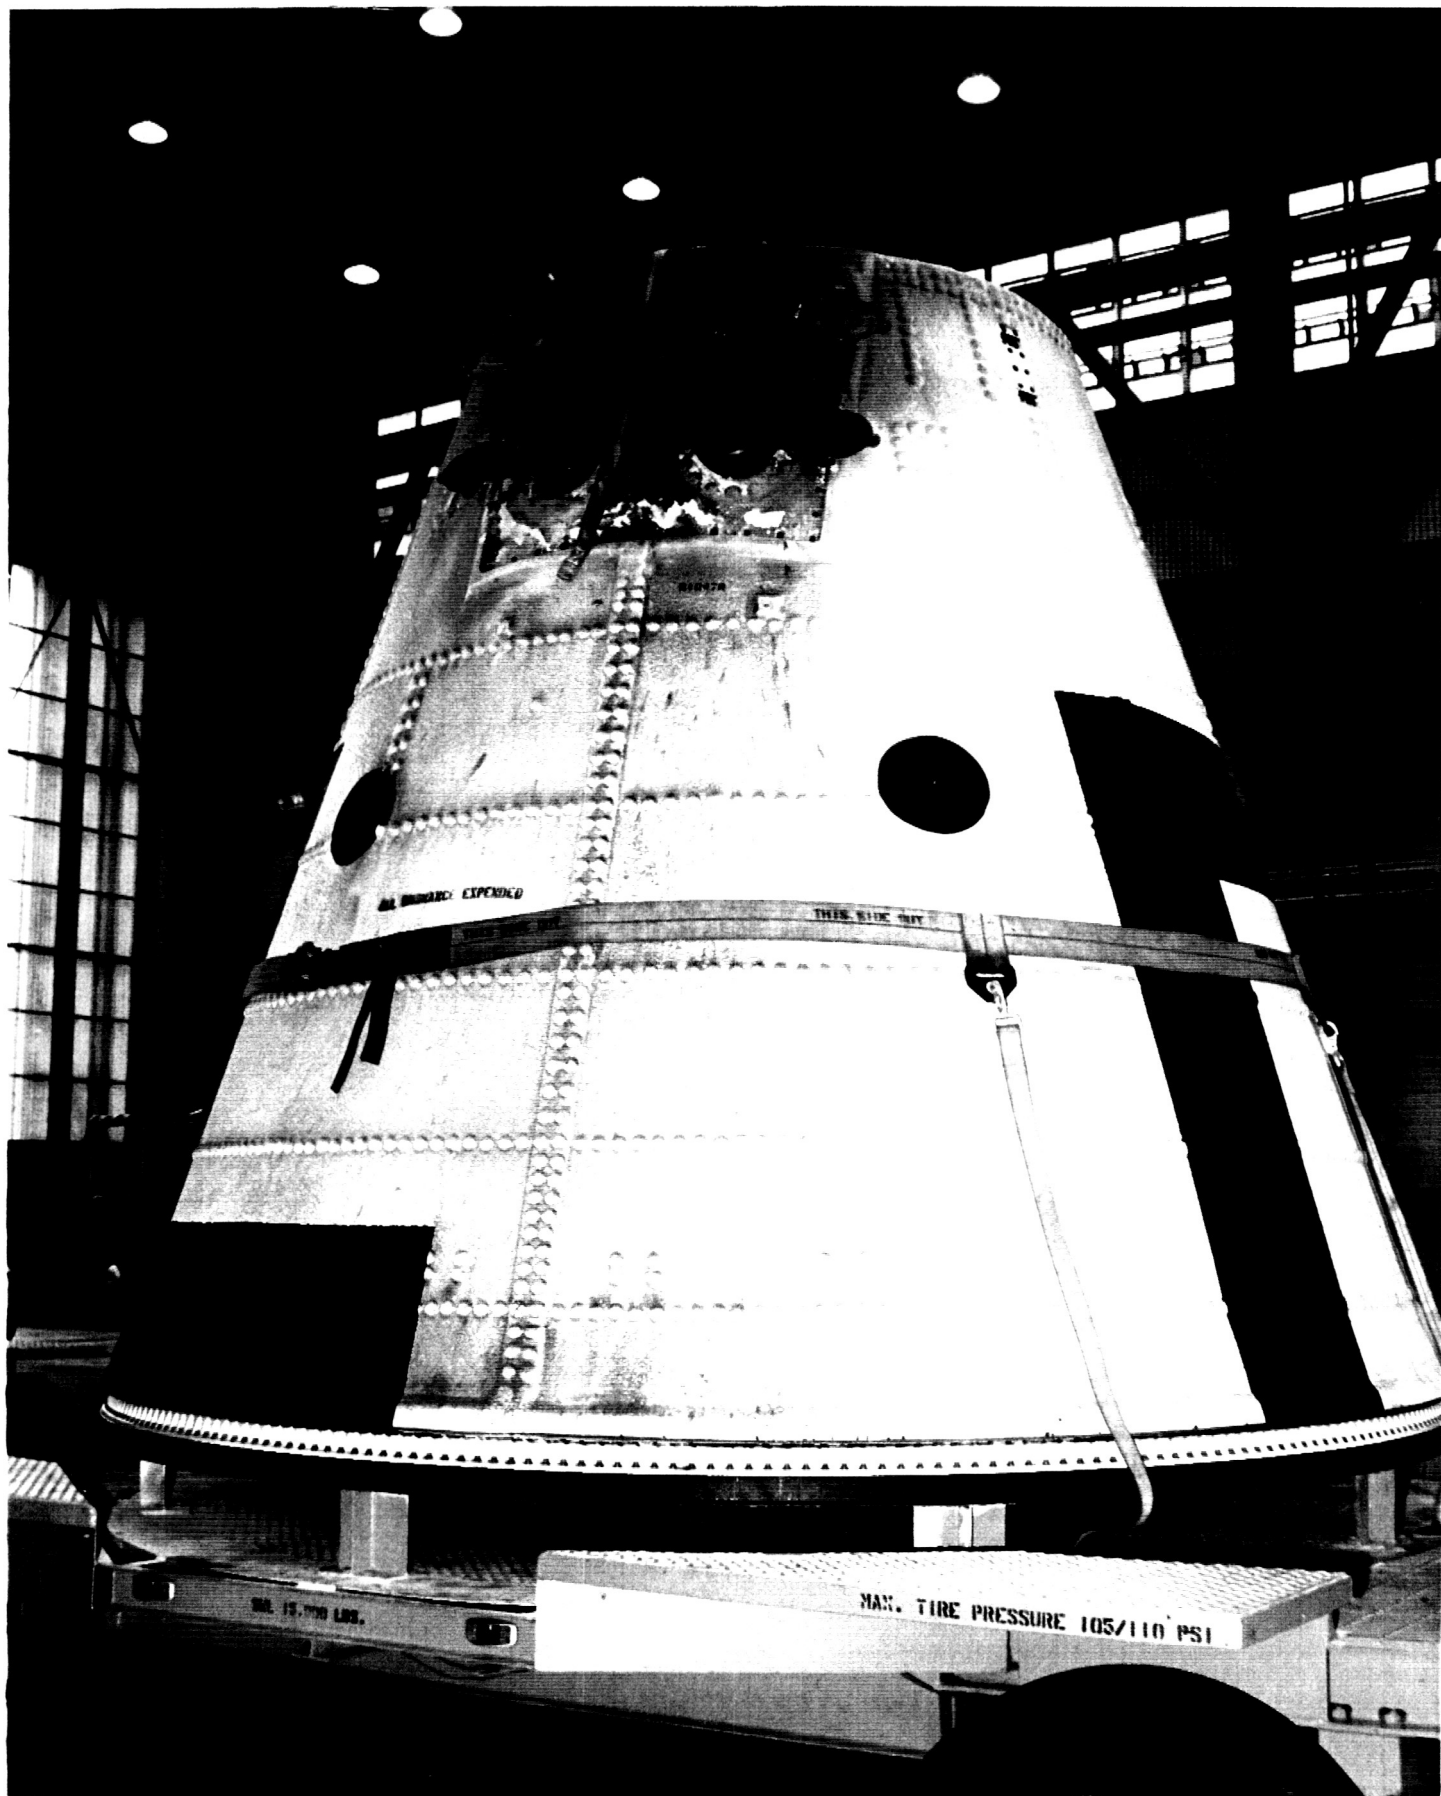
The RH frustum had 8 MSA-2 debonds over fasteners. Although one small piece of MSA-2 was missing near the 275 ring frame, the remaining material in the divot was not sooted and the missing material was most likely lost after re-entry.

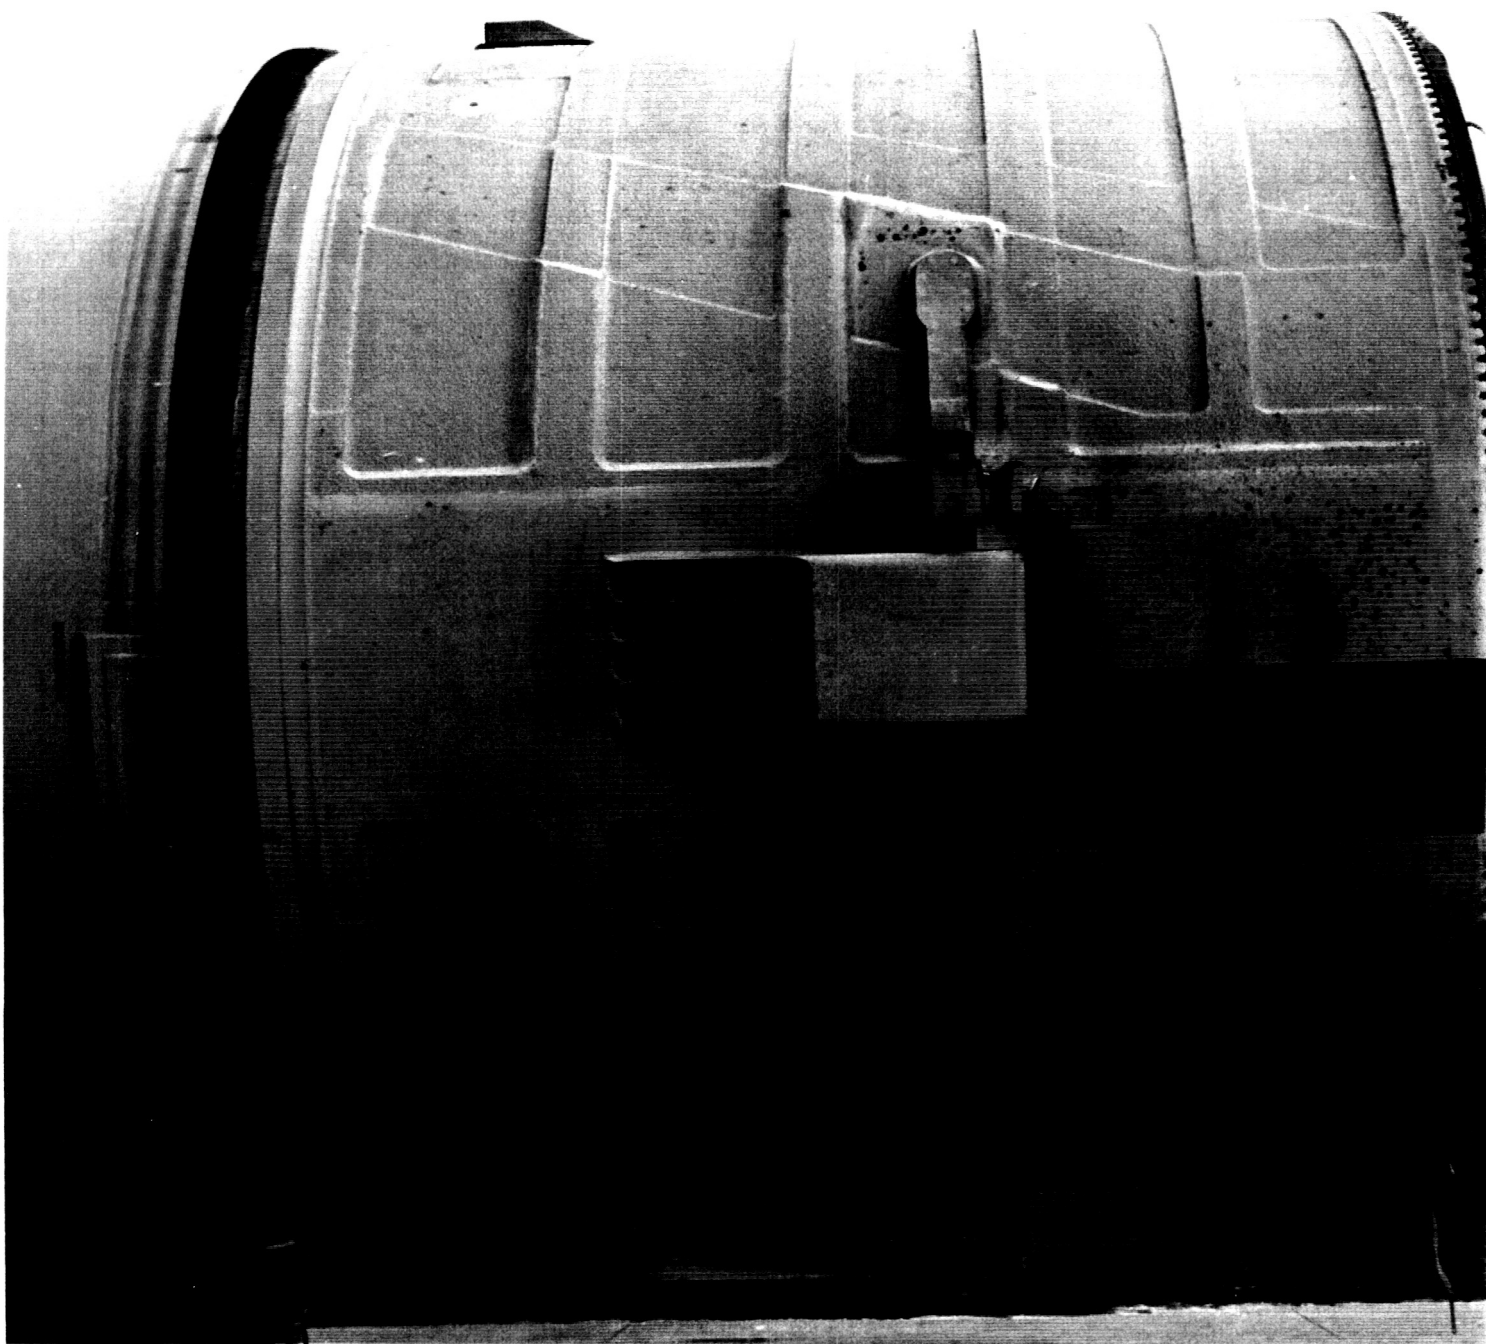
The RH forward skirt exhibited no debonds or missing TPS. Both RSS antenna phenolic plates were intact. Minor blistering of the Hypalon paint occurred forward of the ET/SRB attach point.

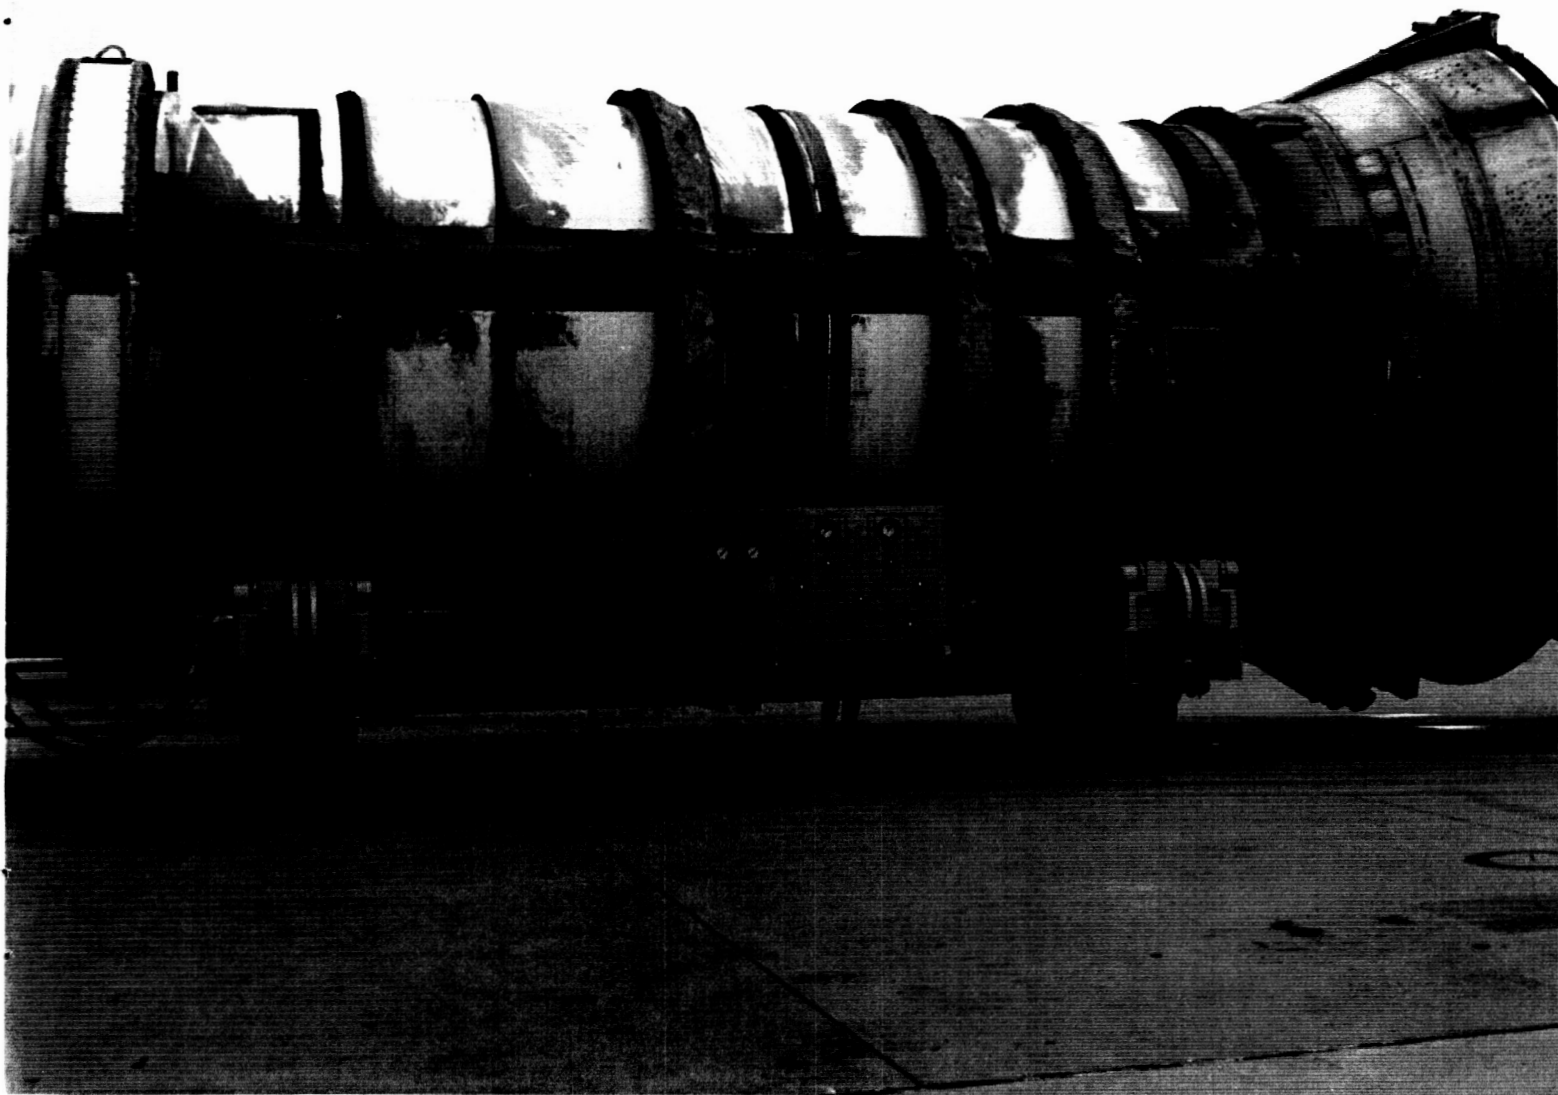
Post flight condition of the RH aft booster. The aft skirt acreage TPS was sooted but in good condition. The ET/SRB aft struts, ETA ring, IEA, and all three aft booster stiffener rings appeared undamaged.

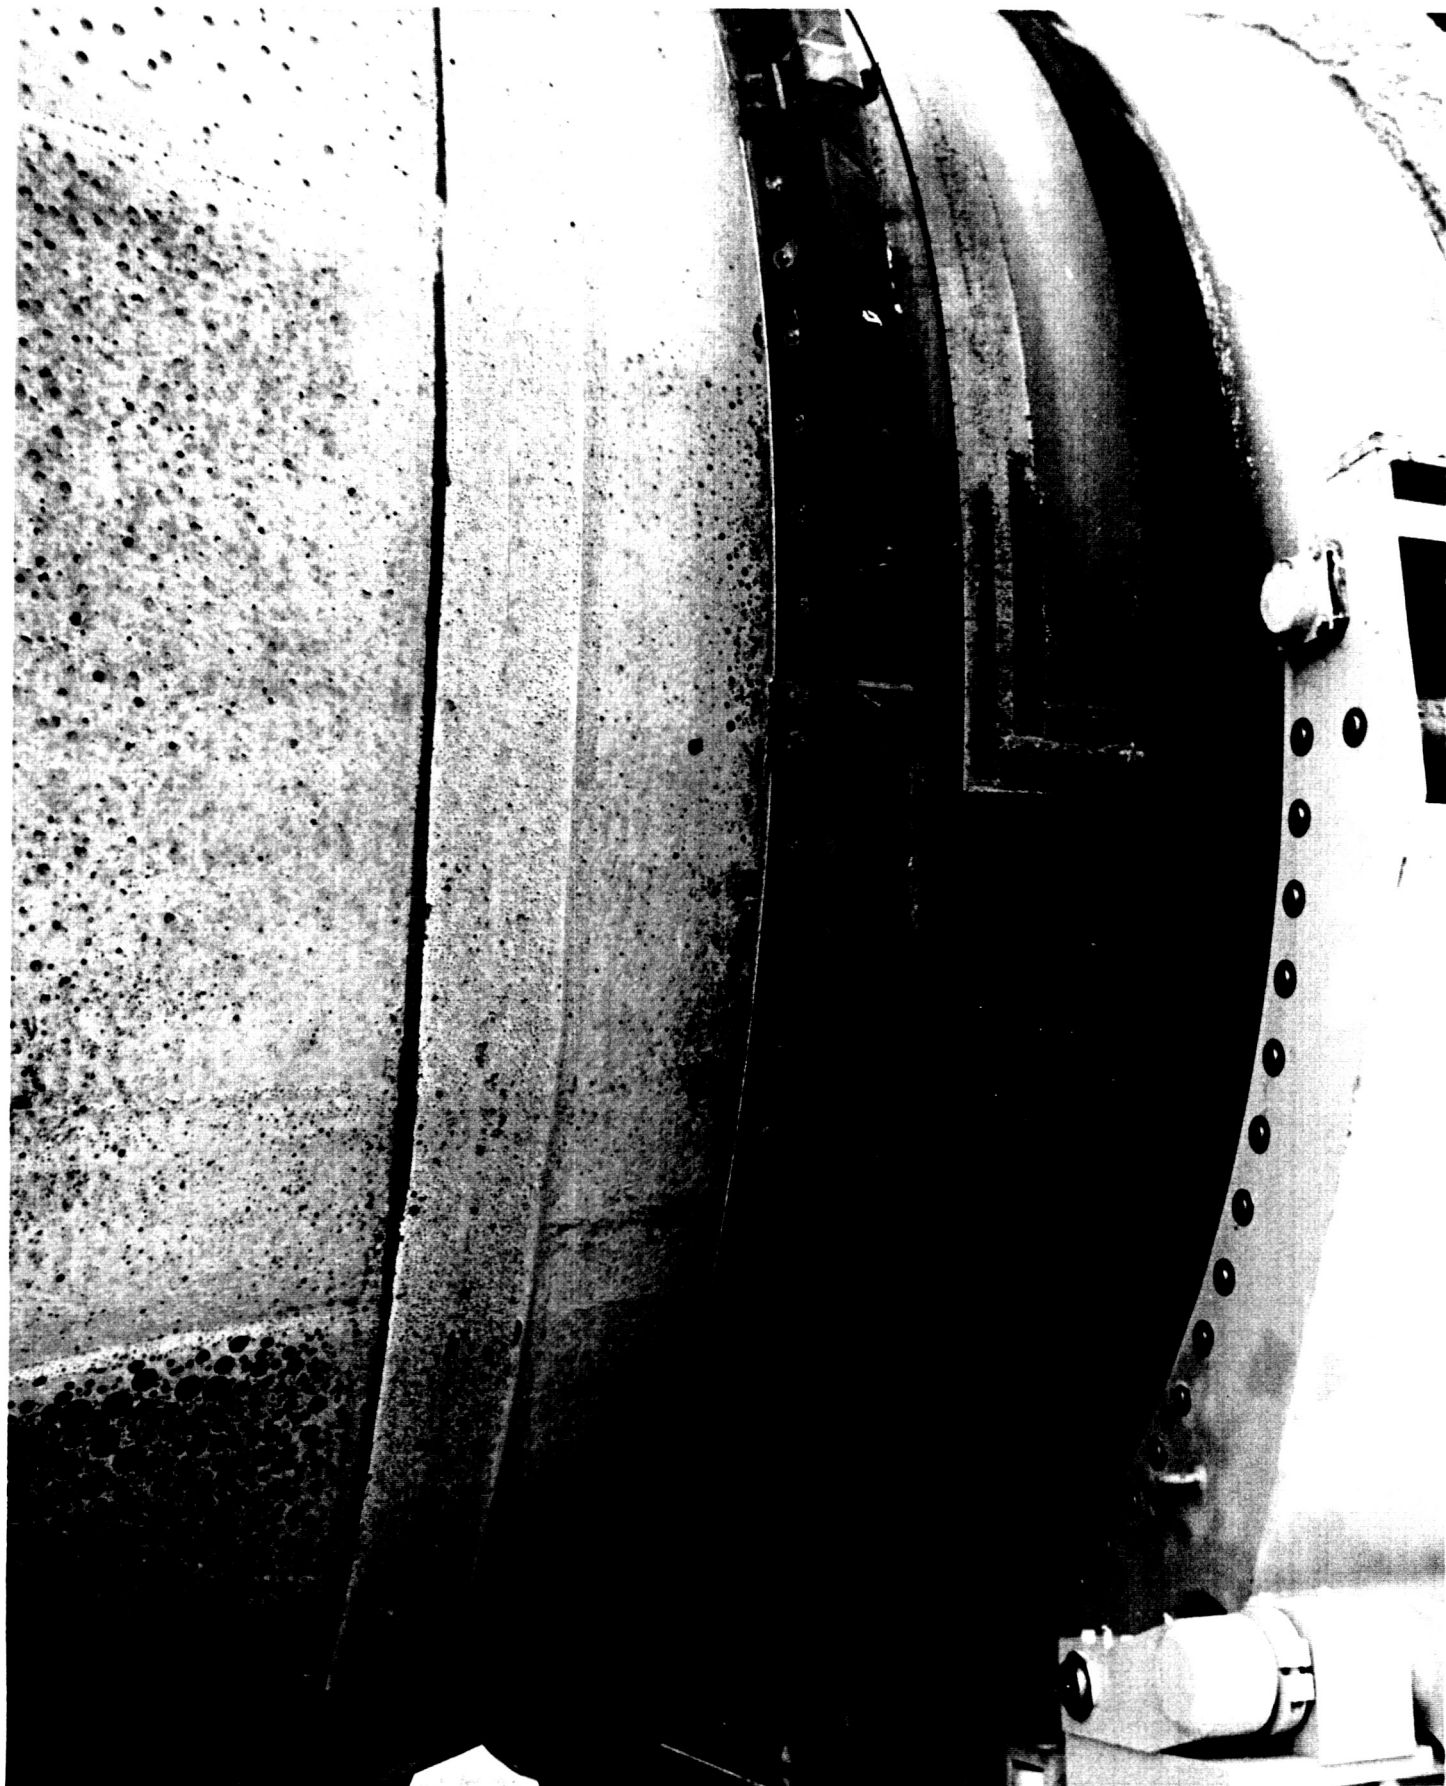
The phenolic material on the kick ring was delaminated between the -Z and +Z axes. Thirteen K5NA protective domes were lost from bolt heads on the aft side of the phenolic kick ring after re-entry.

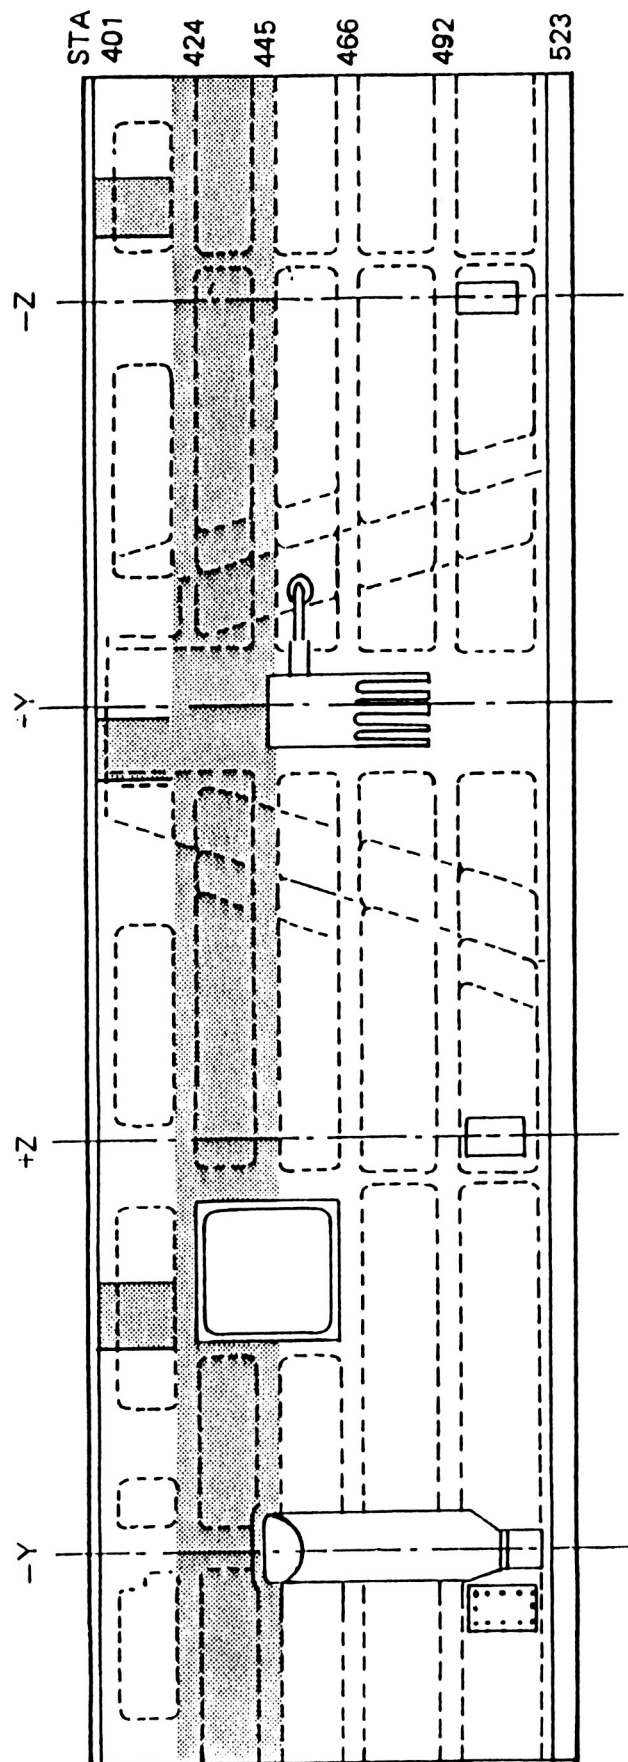
FIGURE 9. LEFT SRB FWD SKIRT

MINOR BLISTERING OF HYPALON  
PAINT ON SYSTEMS TUNNEL  
COVER AND AROUND ET/SRB  
ATTACH FITTING

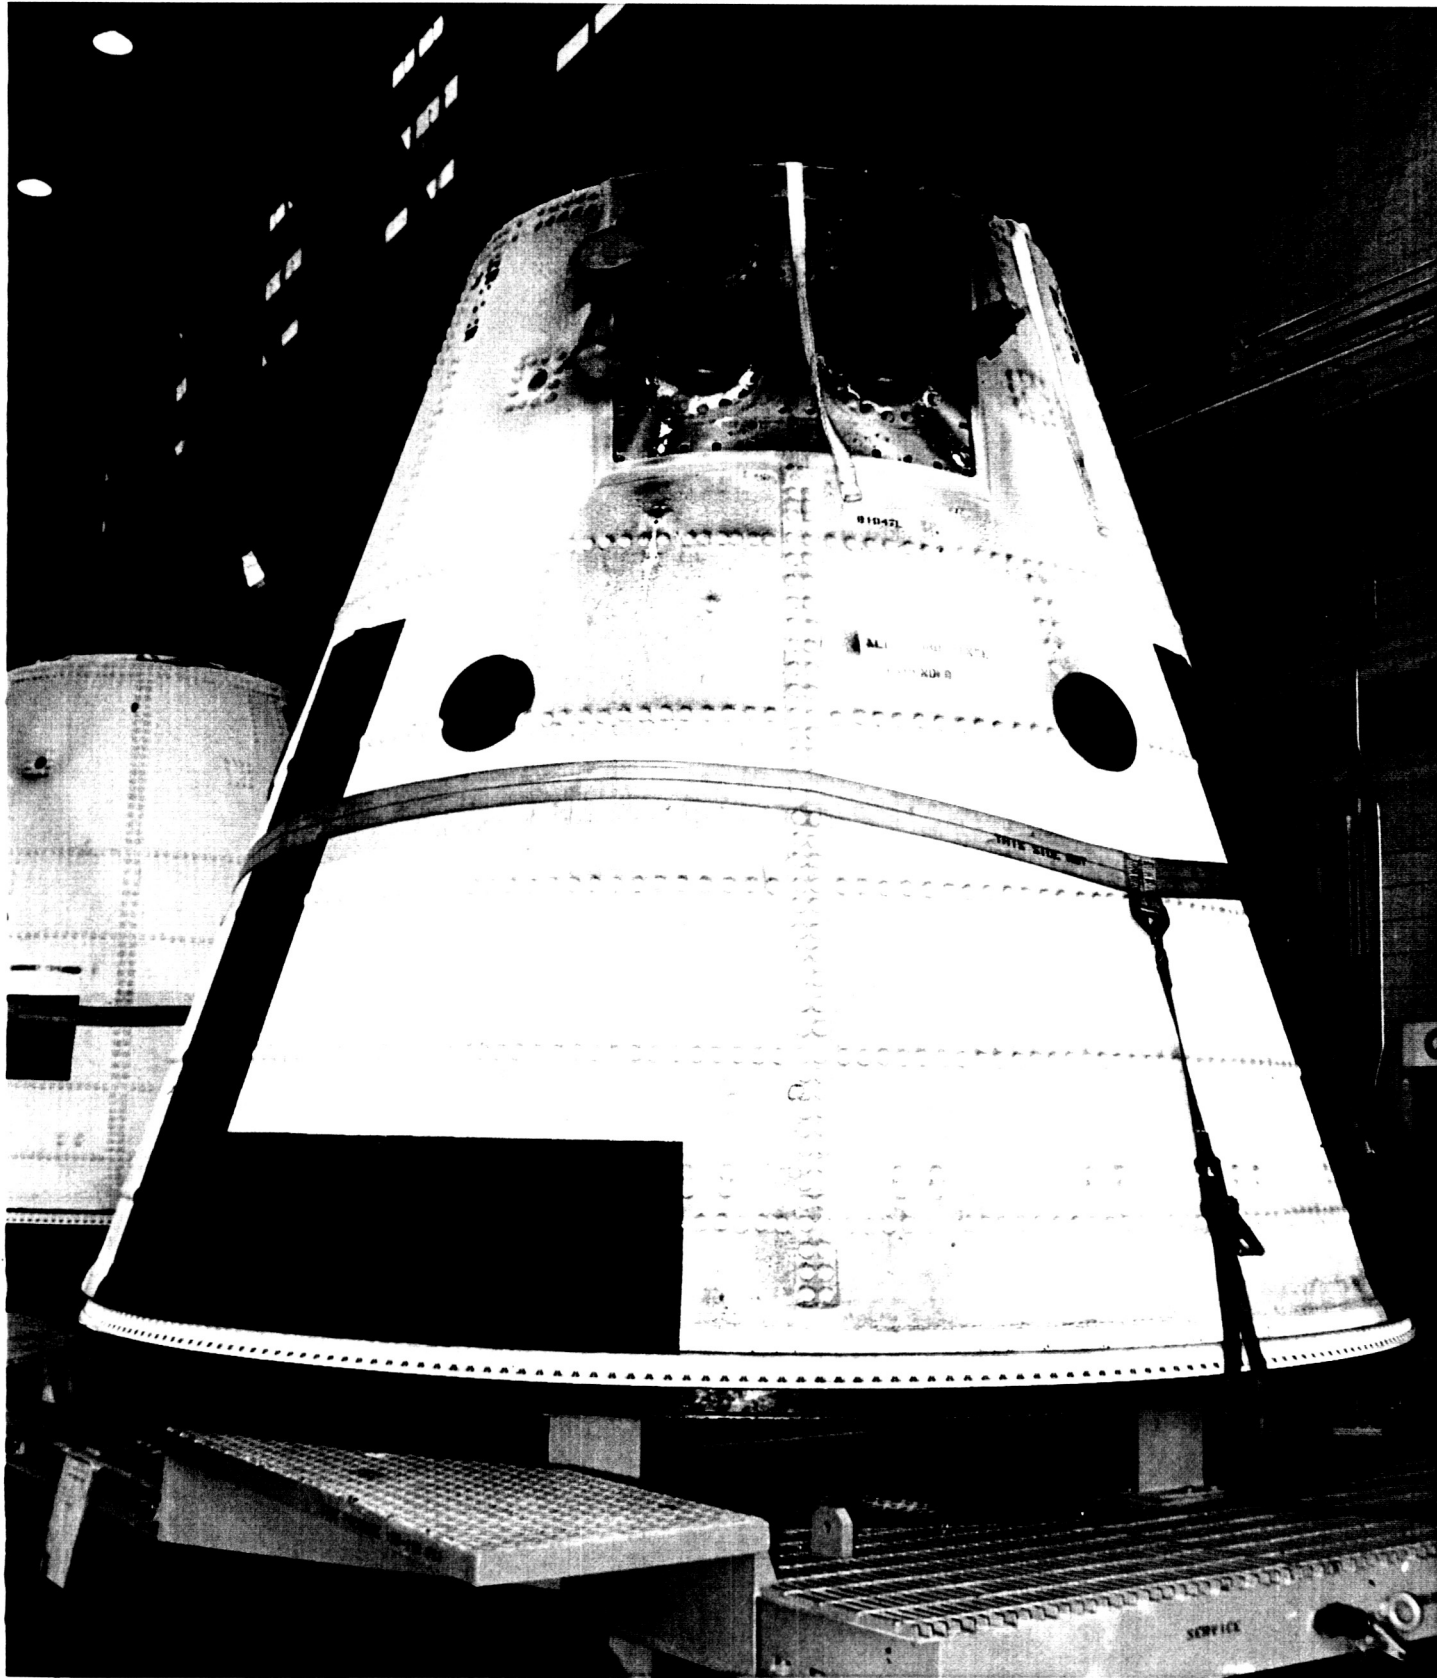
The LH frustum had 11 MSA-2 debonds over fasteners. Although one small piece of MSA-2 was missing near the 275 ring frame, the remaining material in the divot was not sooted and the missing material was most likely lost after re-entry. The BSM covers had locked in the fully opened position, though the upper and lower right cover attach rings were deformed and the covers bent back to the 135 degree position.

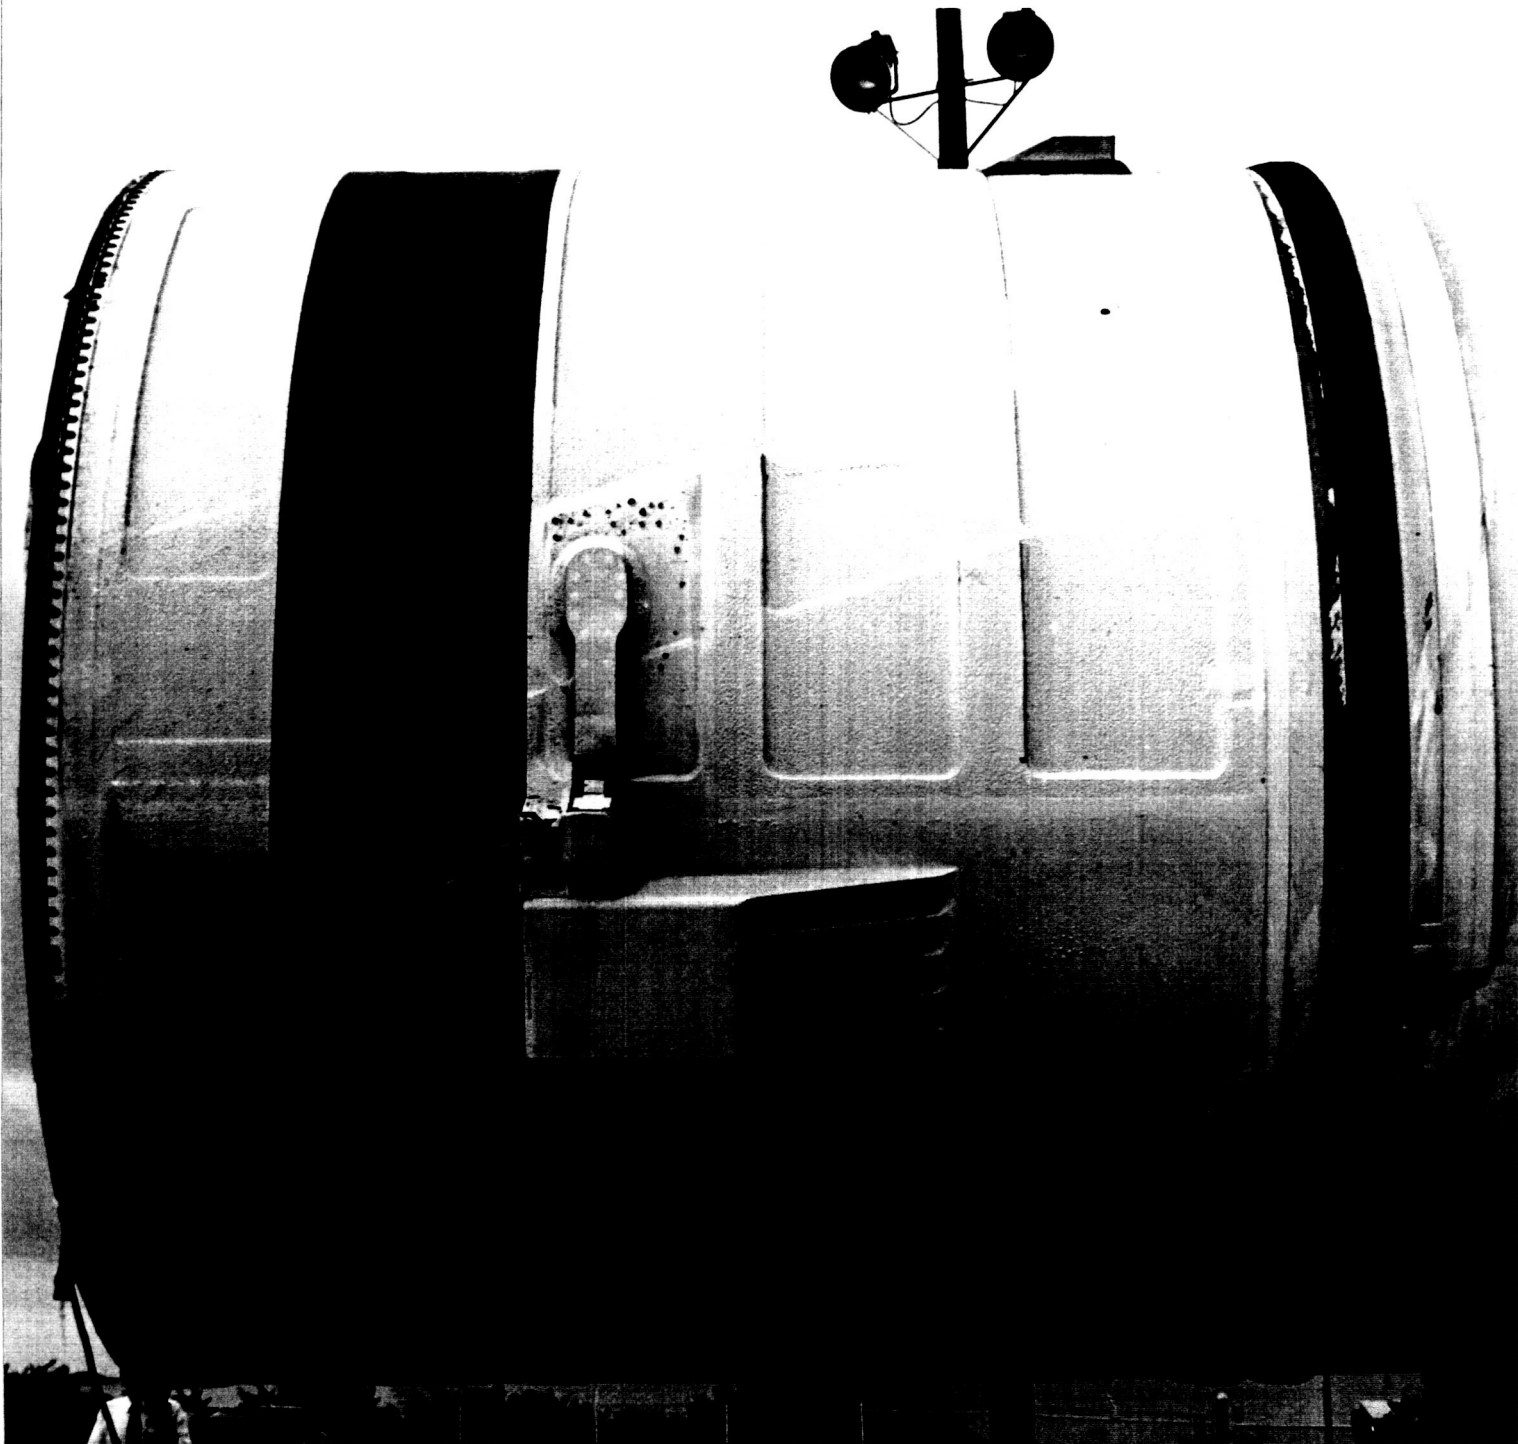
The left forward skirt exhibited no MSA-2 debonds or missing TPS. Minor blistering of Hypalon paint occurred forward of the ET/SRB attach point.
